# YORK RIVER BASIN

Name of Dam: Thelma Pitts Dam

Inventory Number: VA 03343

## PHASE I INSPECTION REPORT NATIONAL DAM SAFETY PROGRAM

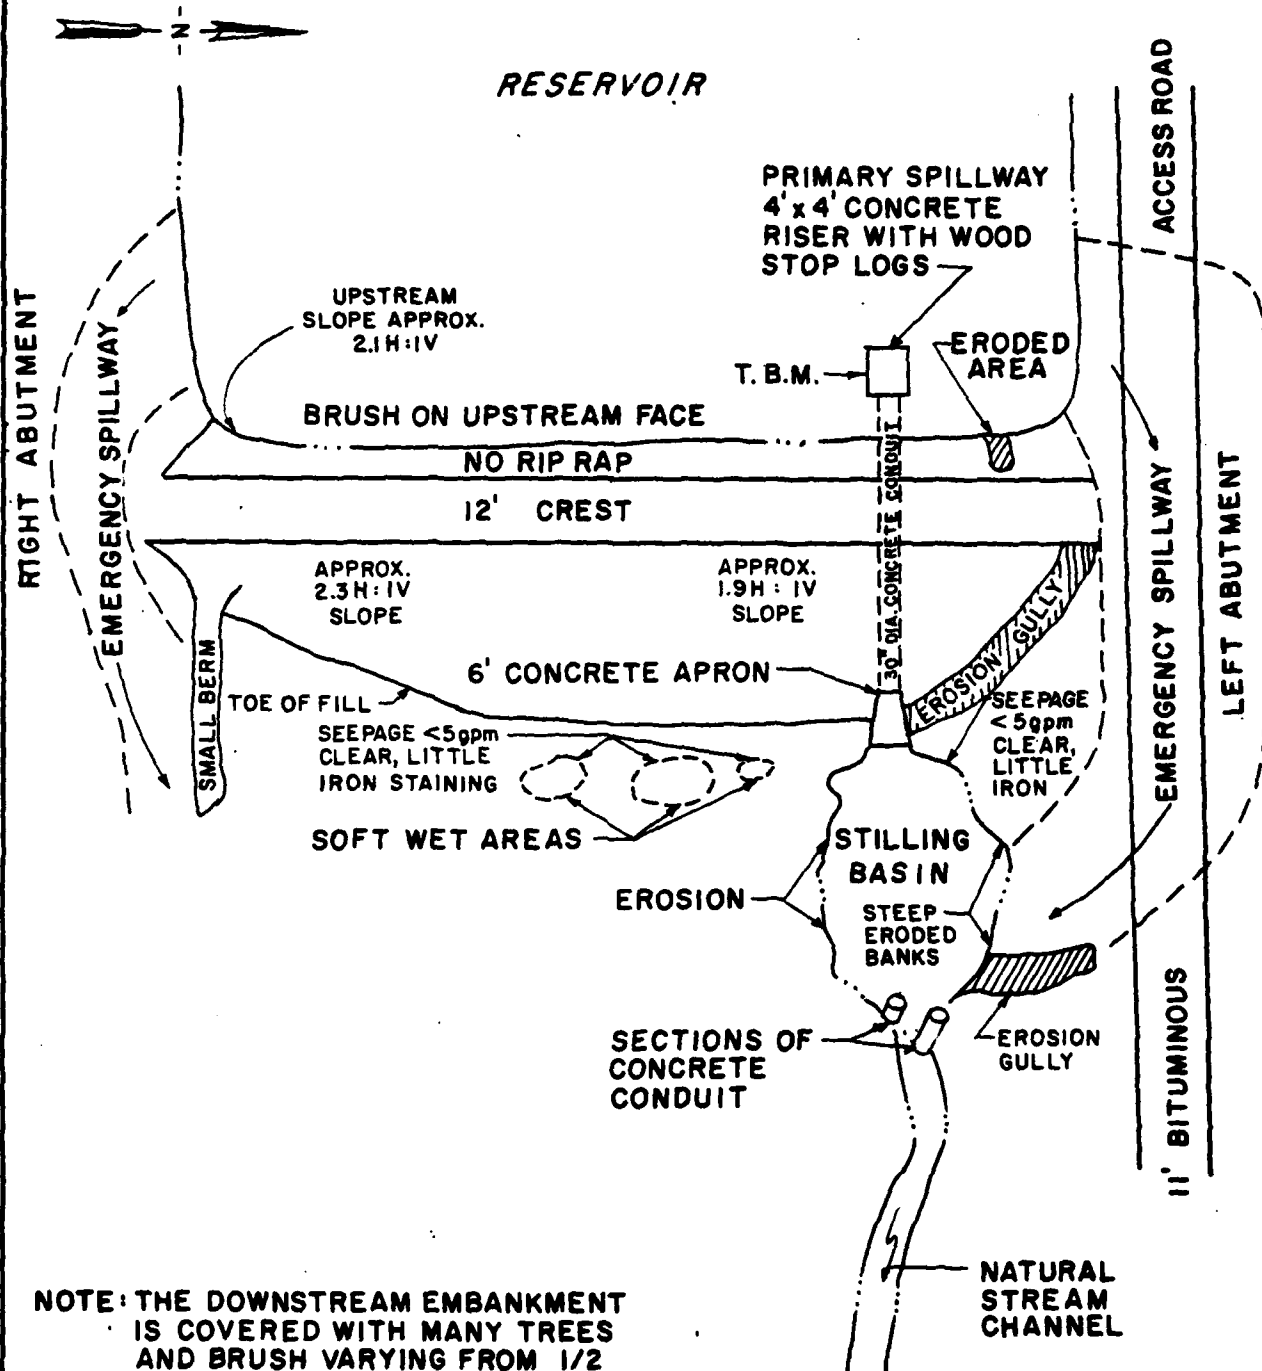
### FIELD SKETCH

NOTE: THE DOWNSTREAM EMBANKMENT  
IS COVERED WITH MANY TREES  
AND BRUSH VARYING FROM 1/2  
INCH TO NEARLY A FOOT IN  
DIAMETER.
